THERMOGRAPHIC INSPECTION REPORT

Royal Suite Hotels

Buena Park

9/29/99

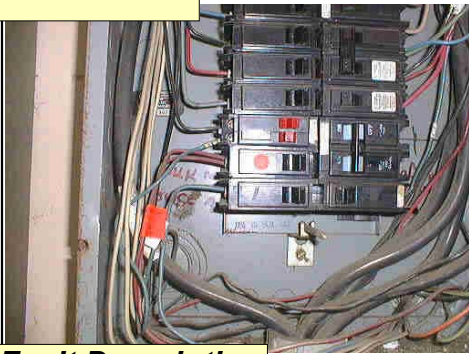
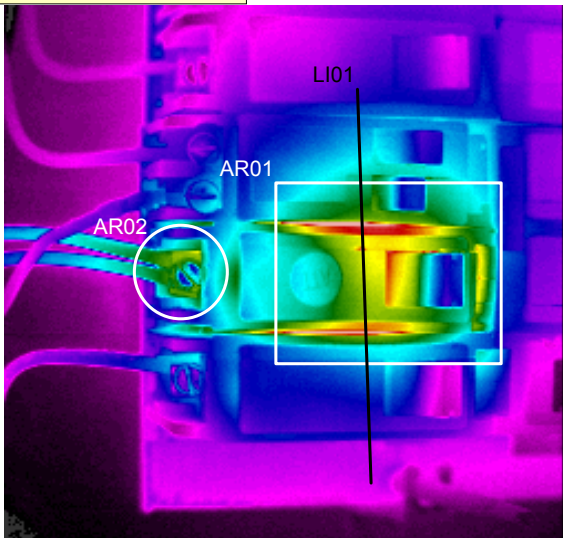
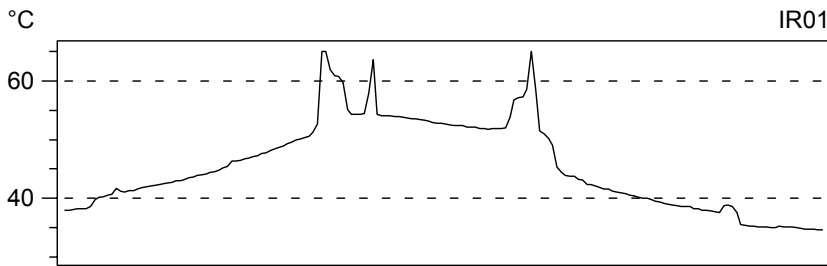
Priority: B	Inspected Equipment: Center Building Panel "ED"	Operator: Sal DiFrancia ThermaCAM PM280	A02.tif
--------------------	--	---	---------

Company	Royal Suite Hotels
9/28/99	09:09:20 PM
Center Building	Panel "ED"
Breaker @Amps	20
Measured @Amps	11
Percentage @%	52%
Fault	Hot Breaker
Recommendation	Inspect, clean and Replace

Object parameter	Value
Emissivity	0.93
Object distance	1.0 m
Ambient temperature	23.0°C
Transmission	0.95
Relative humidity	0.50
Label	Value
LI01 : max	>65.0°C
AR01 : max	>65.0°C
AR02 : max	54.9°C

This breaker is loaded only to 52% capacity. The temperature increase with further loading will be exponential. It represents an **"B" priority** item.

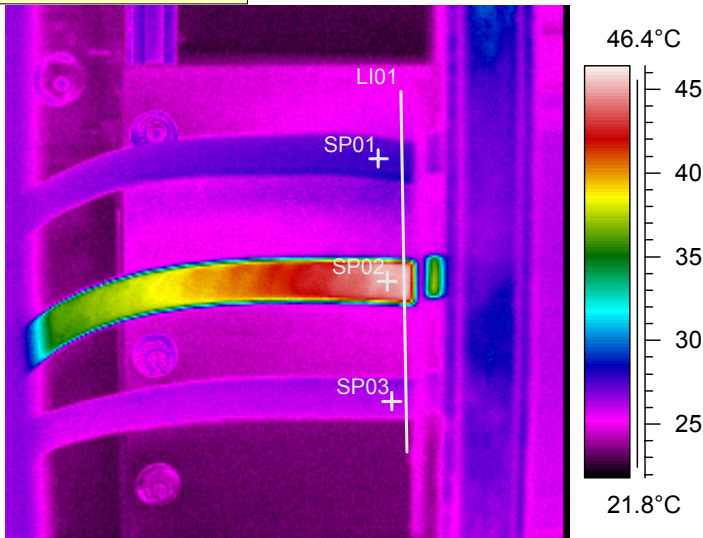
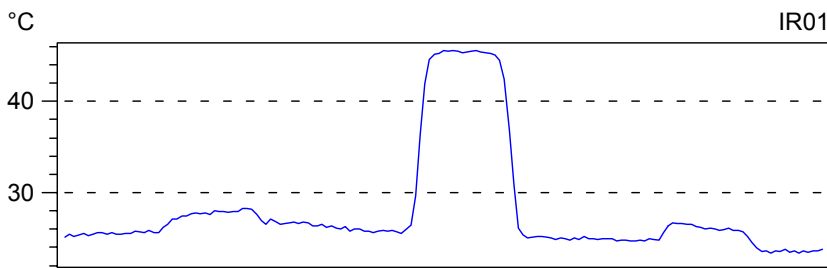
Priority: C	Inspected Equipment: Northside Building "B"	Operator: Sal DiFrancia
	Main Pwr Panel #2 (East)	ThermaCAM PM280 A07.tif

Company	Buena Park
9/28/99	09:44:52 PM
Northside Building	Main Pwr Panel #2 (East)
Breaker @Amps	N/A
Measured @Amps	14/13/6
Percentage @%	N/A
Fault	Hot Lead
Recommendation	Inspect, clean and tighten

Object parameter	Value
Emissivity	0.93
Object distance	1.0 m
Ambient temperature	23.0°C
Transmission	0.95
Relative humidity	0.50
Label	Value
SP01	27.6°C
SP02	45.1°C
SP03	26.1°C
LI01 : max	45.6°C

This breaker represents a 20°C rise, "C" priority. It appears to be a loose cable connector.

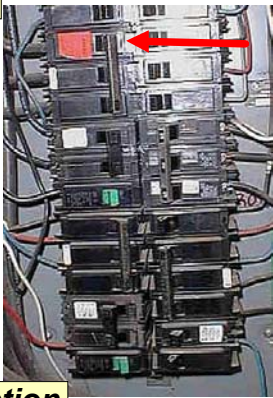
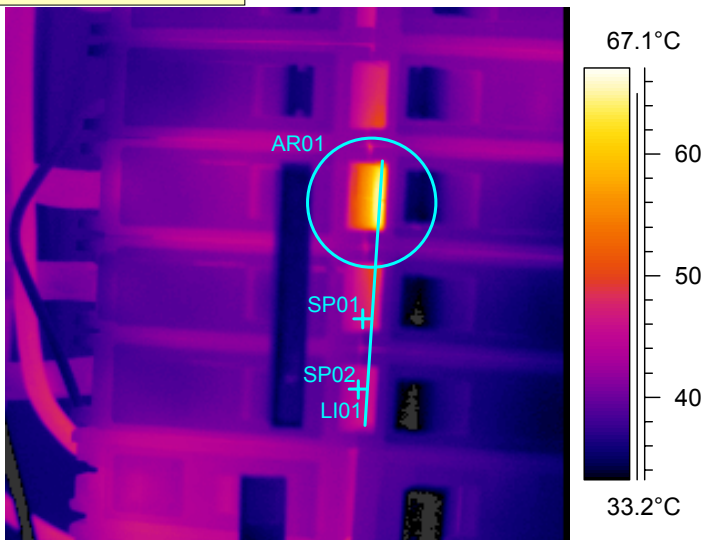
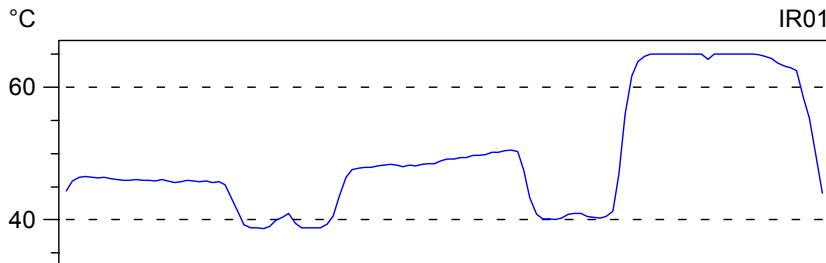
Priority: C	Center Building Inspected Equipment: Panel "EA"	Operator: Sal DiFrancia ThermaCAM PM280 A03.tif
--------------------	--	--

Company	Royal Suite Hotels
9/28/99	09:14:43 PM
Center Building	Panel "EA"
Breaker @Amps	60
Measured @Amps	N/A
Percentage @%	N/A
Fault	Hot Breaker
Recommendation	Inspect, clean or replace

Object parameter	Value
Emissivity	0.93
Object distance	1.0 m
Ambient temperature	23.0°C
Transmission	0.95
Relative humidity	0.50
Label	Value
SP01	47.0°C
SP02	45.1°C
LI01 : max	>65.0°C
AR01 : max	>65.0°C

This is a triple breaker set and there appears to be excess heating at the inside clip for the top breaker in this set. With **20°C** rise, **"C"** priority.

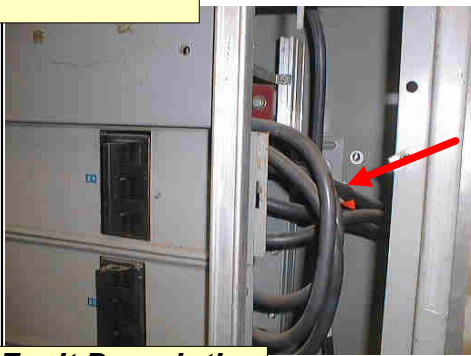
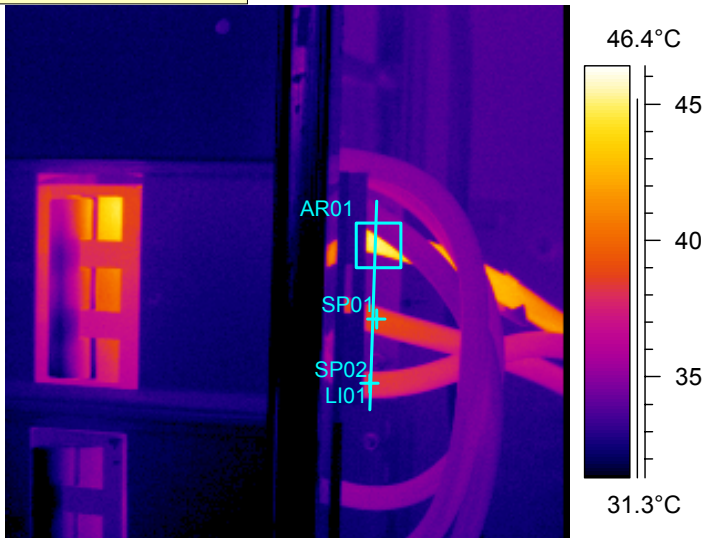
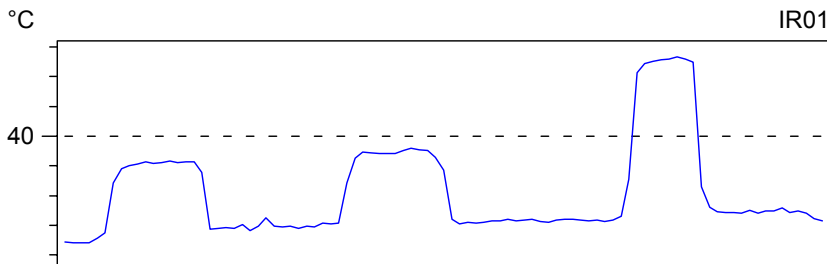
Priority: D	Center Building Inspected Equipment: Main Breaker Panel	Operator: Sal DiFrancia ThermaCAM PM280 A01.tif
--------------------	--	--

Company	Royal Suite Hotels
9/28/99	09:05:10 PM
Center Building	Main Breaker Panel
Breaker @Amps	100
Measured @Amps	55/60/69
Percentage @%	69%
Fault	"A" Phase hot lead
Recommendation	Inspect, clean and tighten

Object parameter	Value
Emissivity	0.95
Object distance	1.0 m
Ambient temperature	23.0°C
Transmission	0.95
Relative humidity	0.50
Label	Value
SP01	38.9°C
SP02	38.2°C
LI01 : max	45.3°C
AR01 : max	45.3°C

The "A" phase lead in this circuit, main breaker for "EA" sub-panel, is showing a **7°C rise, "D" priority.** Possibly a loose connector.

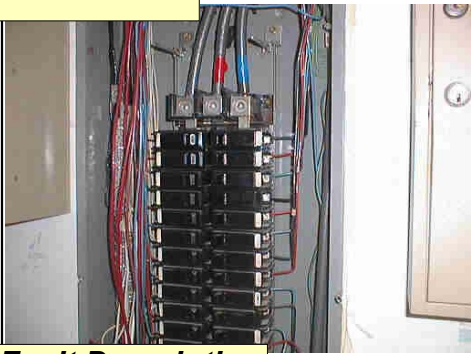
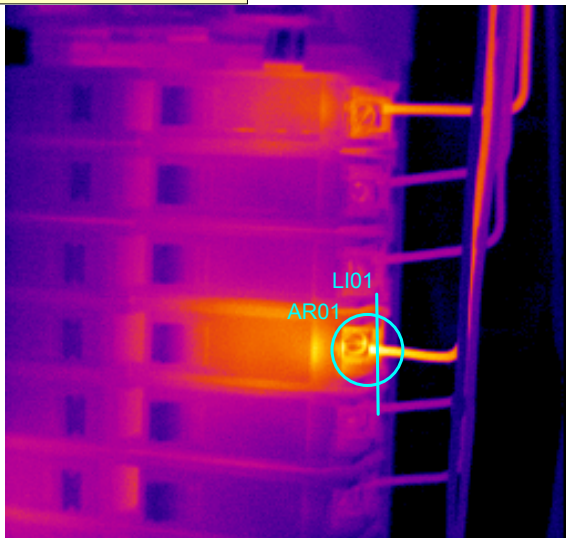
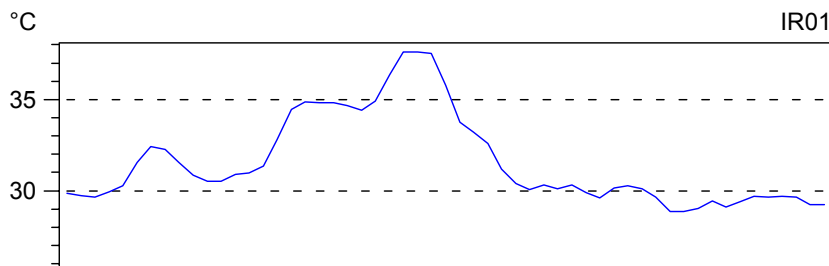
Priority: D	Inspected Equipment: Main Office Panel "AA"	Operator: Sal DiFrancia ThermaCAM PM280	A06.tif
--------------------	--	---	---------

Company	Buena Park
9/28/99	09:26:11 PM
Main Office	Panel "AA"
Breaker @Amps	20
Measured @Amps	16
Percentage @%	80
Fault	Hot connector
Recommendation	Inspect, clean and tighten

Object parameter	Value
Emissivity	0.85
Object distance	1.0 m
Ambient temperature	23.0°C
Transmission	0.95
Relative humidity	0.50
Label	Value
LI01 : max	37.6°C
AR01 : max	38.0°C

A **"D"** priority. This appears to be a minor problem with a loose connection screw.

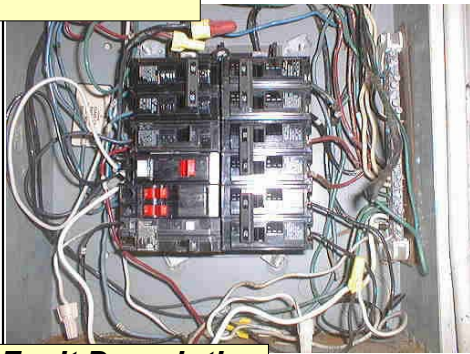
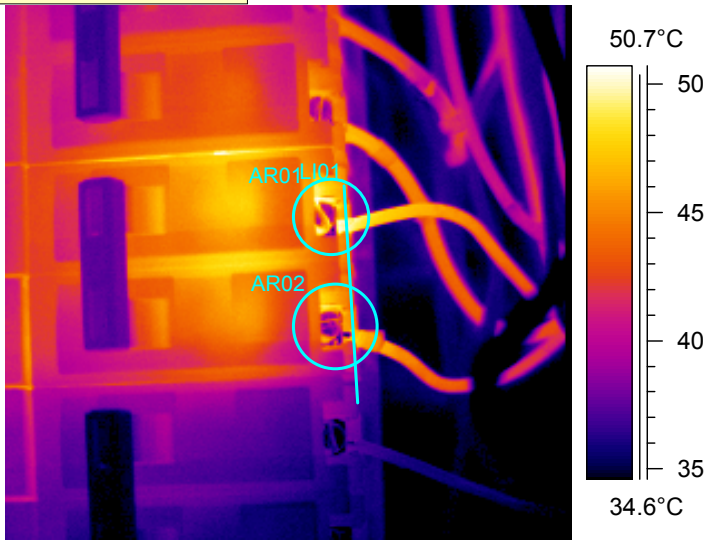
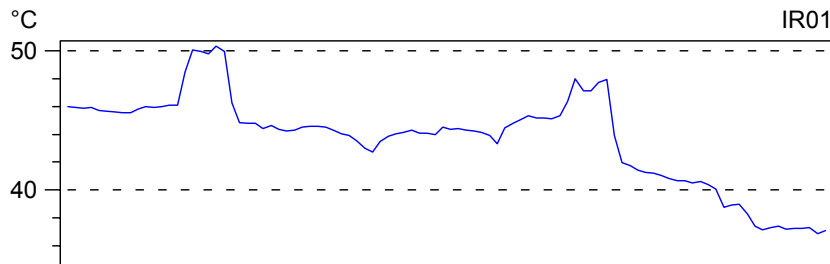
Priority: D	Inspected Equipment: Pool Room	Operator: Sal DiFrancia
	Equipment Panel	ThermaCAM PM280 A09.tif

Company	Buena Park
9/28/99	10:21:24 PM
Pool Room	Equipment Panel
Breaker @Amps	dual 20
Measured @Amps	.07 & .06
Percentage @%	N/A
Fault	Connector screw
Recommendation	Inspect, clean and tighten

Object parameter	Value
Emissivity	0.85
Object distance	1.0 m
Ambient temperature	23.0°C
Transmission	0.95
Relative humidity	0.50
Label	Value
LI01 : max	50.3°C
AR01 : max	50.8°C
AR02 : max	49.2°C

A "**D**" priority item. A possible loose connector screw.
